## **AIRCRAFT SERIOUS INCIDENT REPORT**

FINAL REPORT

ON THE SERIOUS INCIDENT INVOLVING EURO ATLANTIC AIRWAYS BOEING 767-300  
AIRCRAFT REGISTRATION CS-TST WHICH OCCURRED AT SÃO TOMÉ INTERNATIONAL  
AIRPORT ON 29th JULY 2023.

# **NATIONAL ACCIDENT INVESTIGATION COMMISSION**

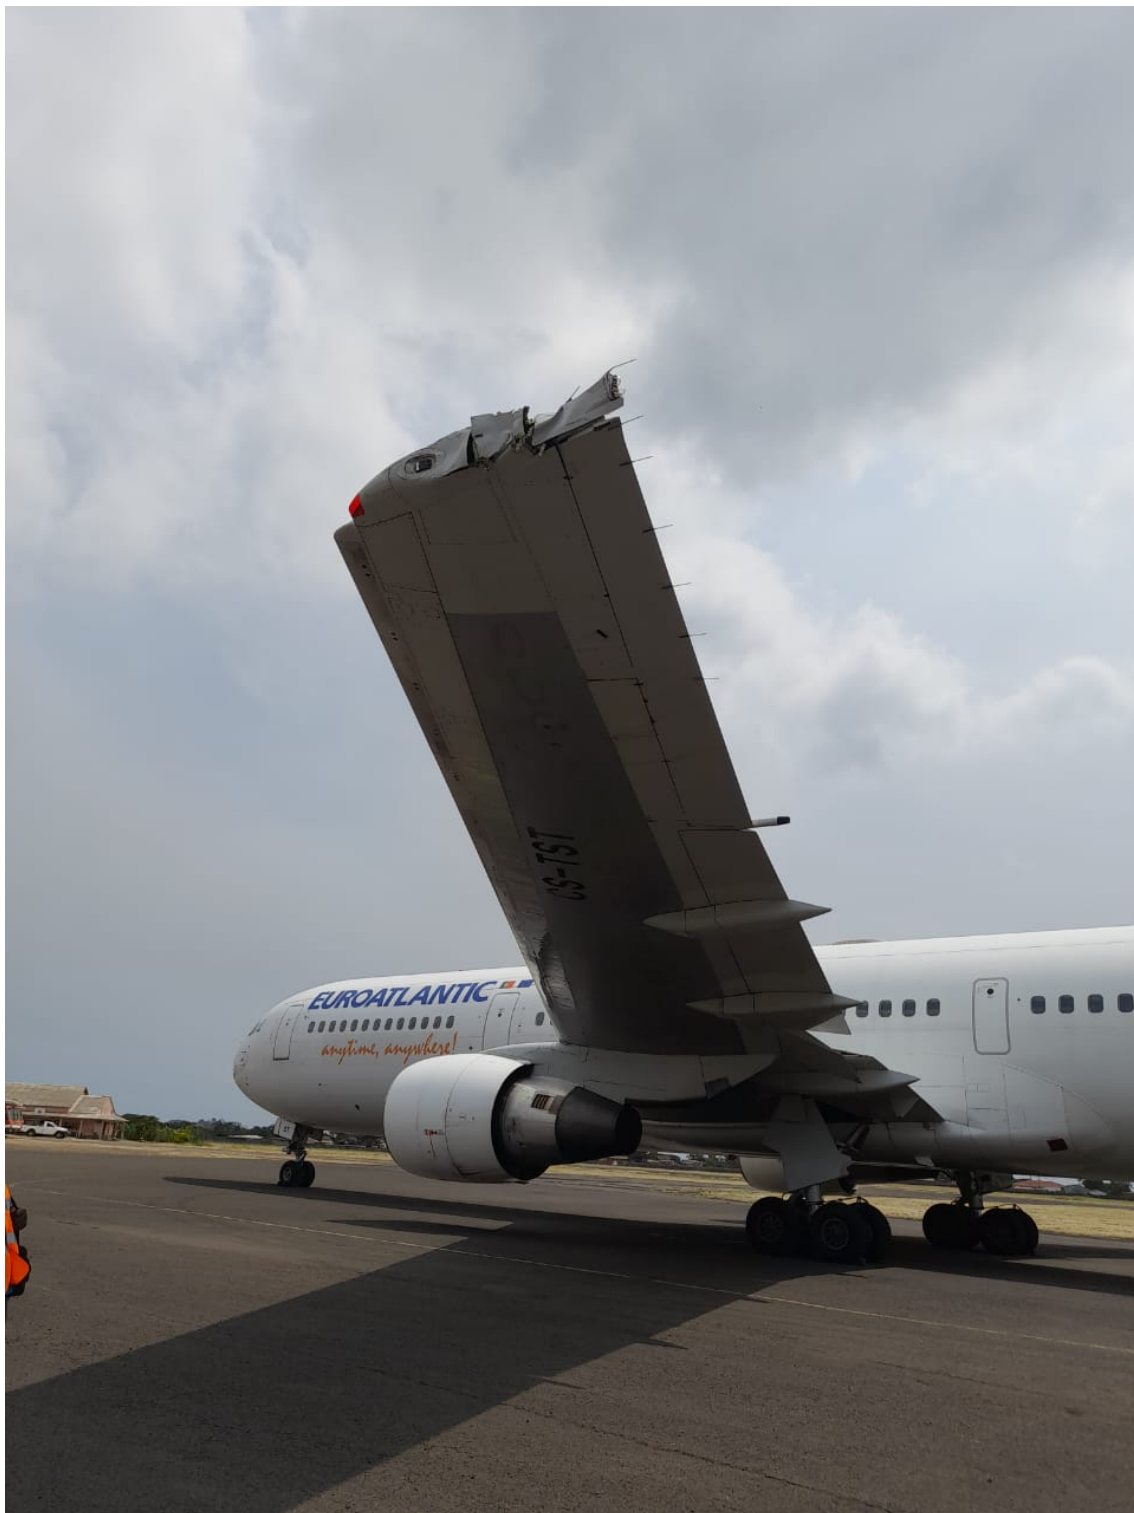
**1.3 DAMAGE TO AIRCRAFT:** Left wing tip damaged

- The wing tip assembly's structure was severely deformed with the skin misshapen and even broken
- The wing top panel flanked by both the aileron and the wing tip assembly was also warped
- The anti-collision light is almost completely missing

Left wing tip damaged

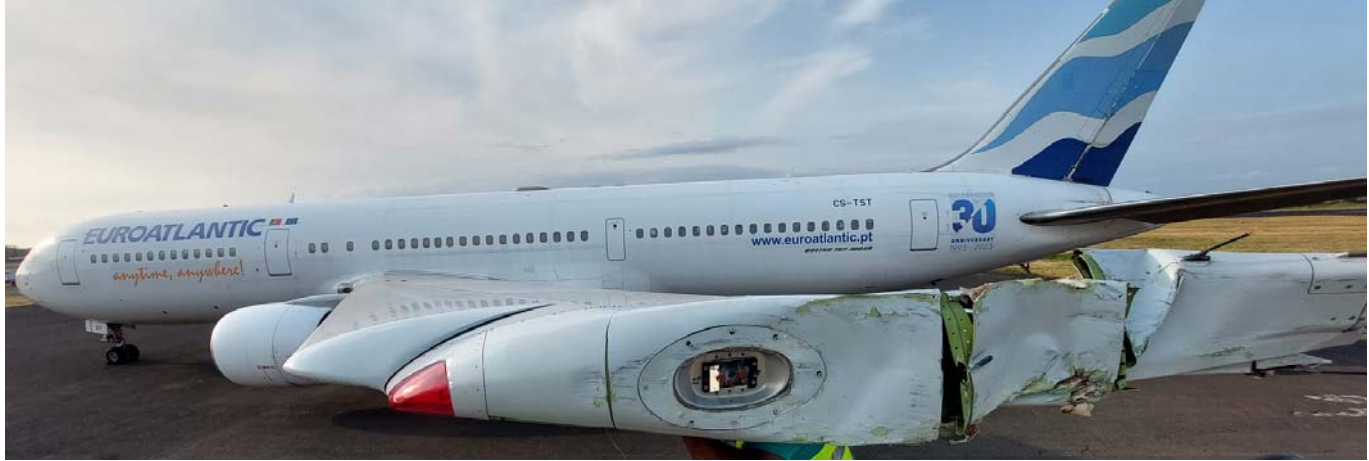
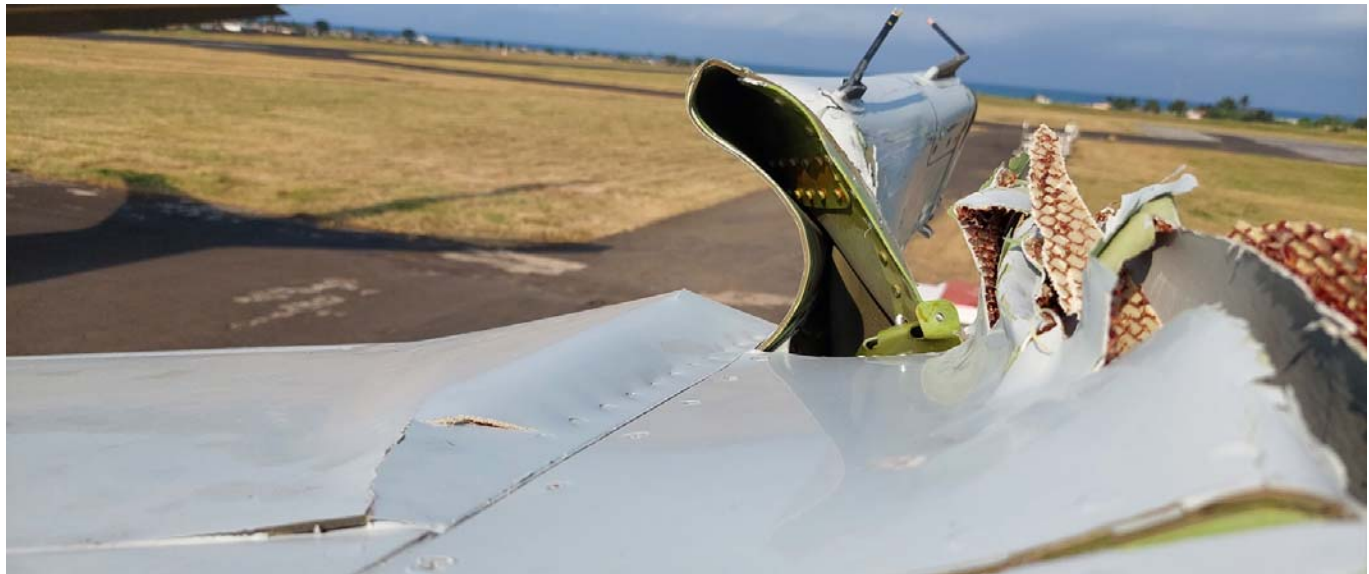
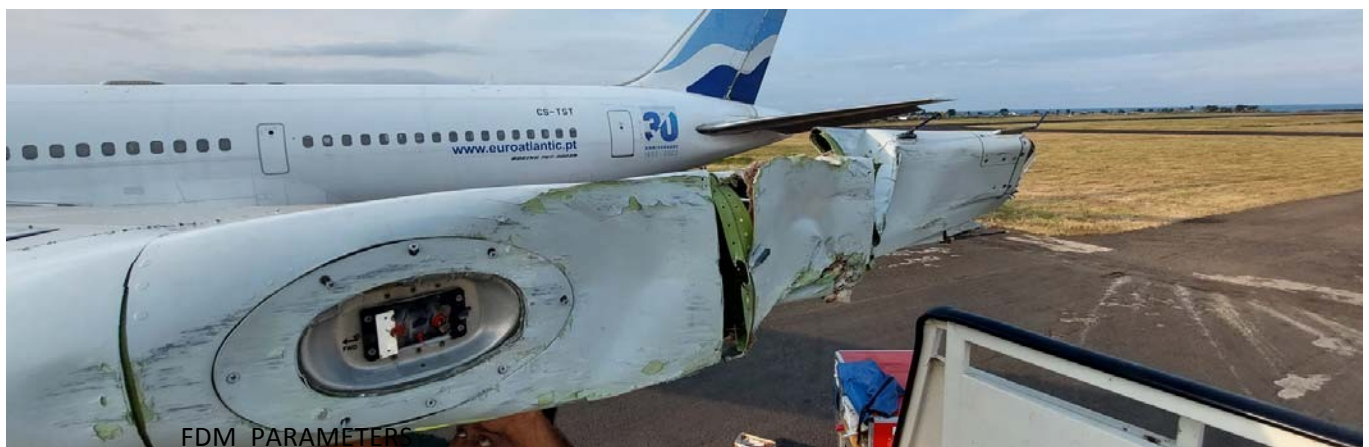
- Wing Tip Assembly completely destroyed, internal structure and skin with damage practically through its entirely

- Outboard Aileron with areas in-between the outboard edge and the trailing edge with composite (honeycomb) destroyed and delaminated (this section of aileron has split open). Aileron End Cap completely destroyed

- Rib with damages (missing section) in the trailing edge area. Wing Tip to Rib attachments and all drilled holes to connect the After Wing Tip are torn

- Panel with multiple fractures and bulging/deformed in the area next to the tip. This panel is completely affixed to the wing with rivets and hi-locks, making its replacement complex

Wing Tip assembly completely destroyed, internal structure and skin with damage practically throughout its entirety.

The maintenance actions on the aircraft were performed namely temporary repairs and corrective actions duly approved by Boeing Company

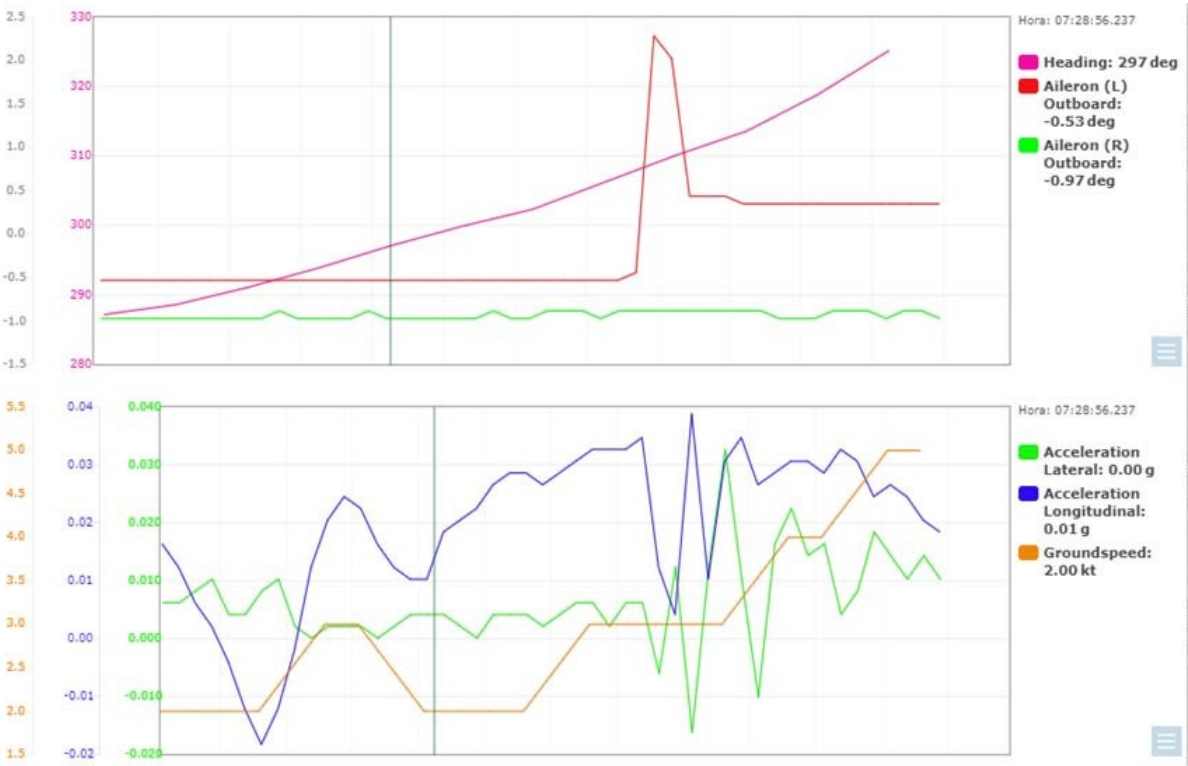
When leaving taxiway, the aircraft started the parking maneuver as instructed by two marshals. The first turn was made to the left and the second was made to the right and the both were executed without difficulty. Making the next turn (third) to the right the pilot did not complete the necessary 90° and caused him to become disoriented regarding the correct position of the aircraft on that leg of the taxiing and not realizing he was out of safety margin and not having perception that the aircraft left wing was going to hit the lighting pole.

FDM parameters giving an understanding the timeline of events
