# **AIRCRAFT ACCIDENT REPORT**

FINAL REPORT ON THE ACCIDENT INVOLVING  
AEROJET SAAB 340 AIRCRAFT, REGISTRATION UR-ALG  
WHICH OCCURRED AT SÃO TOMÉ INTERNATIONAL AIRPORT  
ON 27th SEPTEMBER, 2021.

# **NATIONAL ACCIDENT INVESTIGATION COMMISSION**

**AIRCRAFT ACCIDENT REPORT Nº:** AEJ/27/09/2021/RF

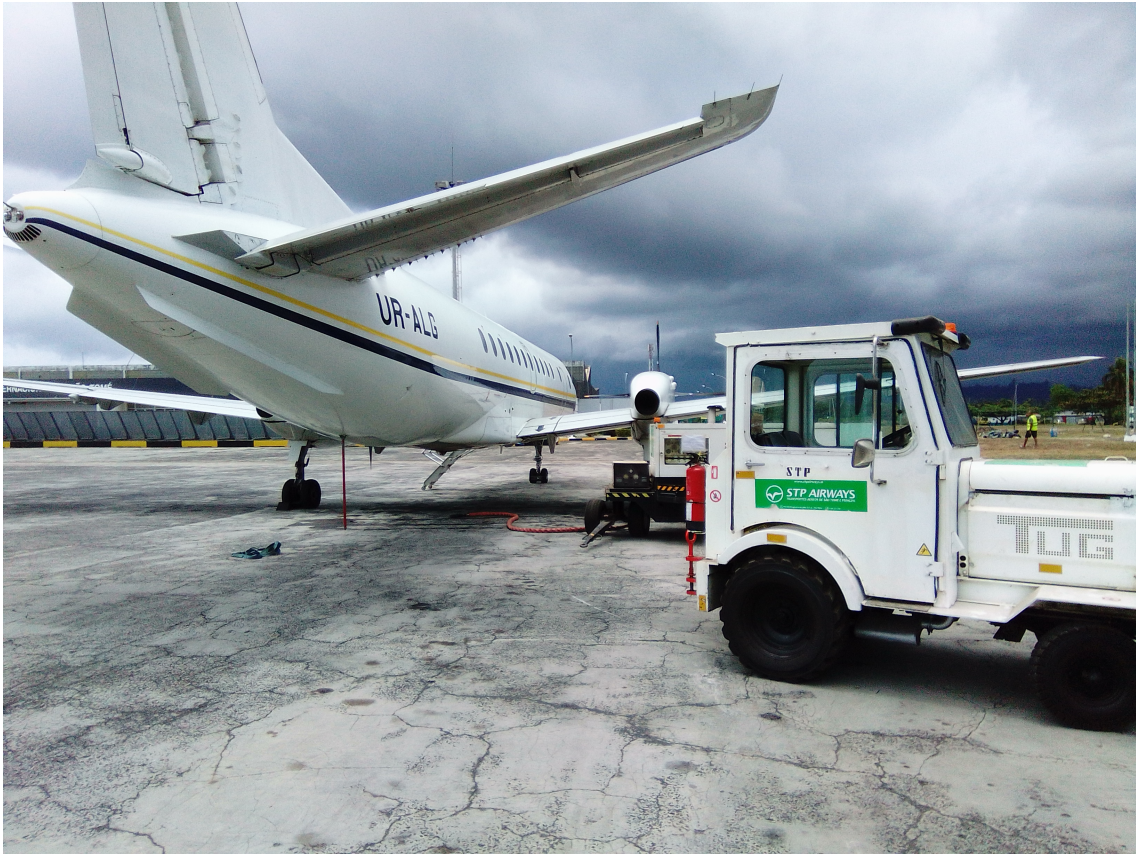
Thereafter the ramp assistant brought the ground power to be connected to the aircraft. While doing so the tractor moved adrift towards the aircraft hitting the fuselage of aircraft and causing damage to fuselage skin on the right side region of cargo/baggage compartment.

Figure 1: Picture showing a pictorial view of the aircraft, tractor and ground power in the apron.

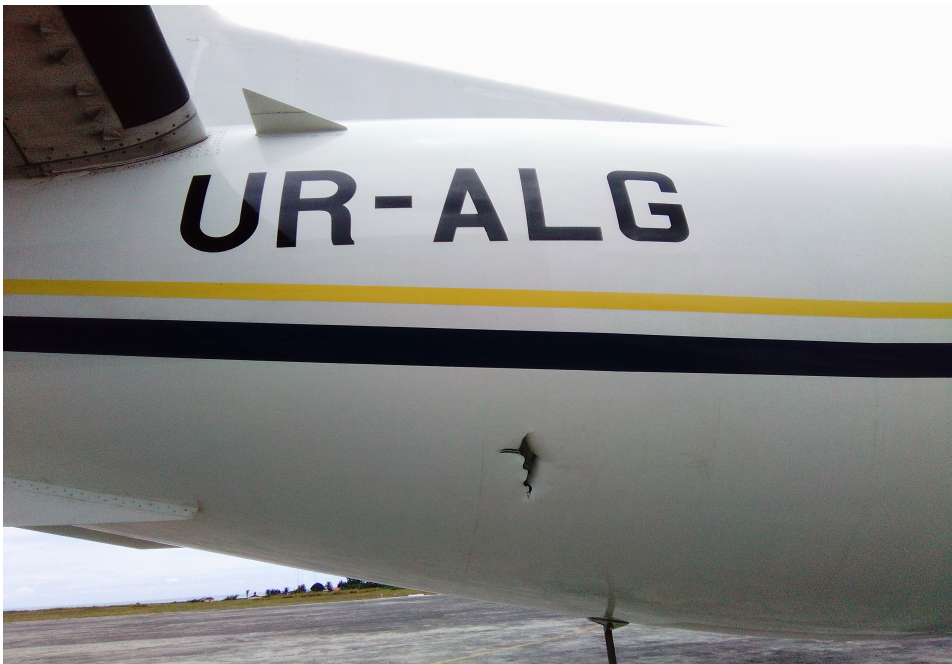
Figure 2: Picture showing damage to right side region of aircraft cargo compartment.

The impact of the tractor that hit the aircraft caused damage to the fuselage skin on the right side region of cargo/baggage compartment with a dimension of approximately 30 x 15 cm.

As next step the ramp assistant brought the ground power to be connected to the aircraft. Before leaving the tractor to proceed to connect the ground power, the ramp assistant should switch off the tractor, apply the parking brake and place the pads accordingly; no doing so the tractor moved adrift towards the aircraft hitting the fuselage causing damage to fuselage skin on the right side region of cargo/baggage compartment with dimension to extent of 30x 15 cm.

Handling operator should improve the maintenance work in order to maintain the ground equipment in perfect condition

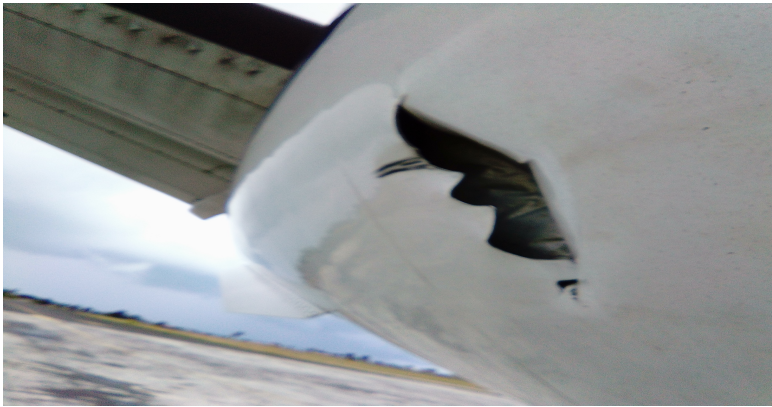
Figure 3: Picture showing damage to right side region of aircraft cargo compartment.

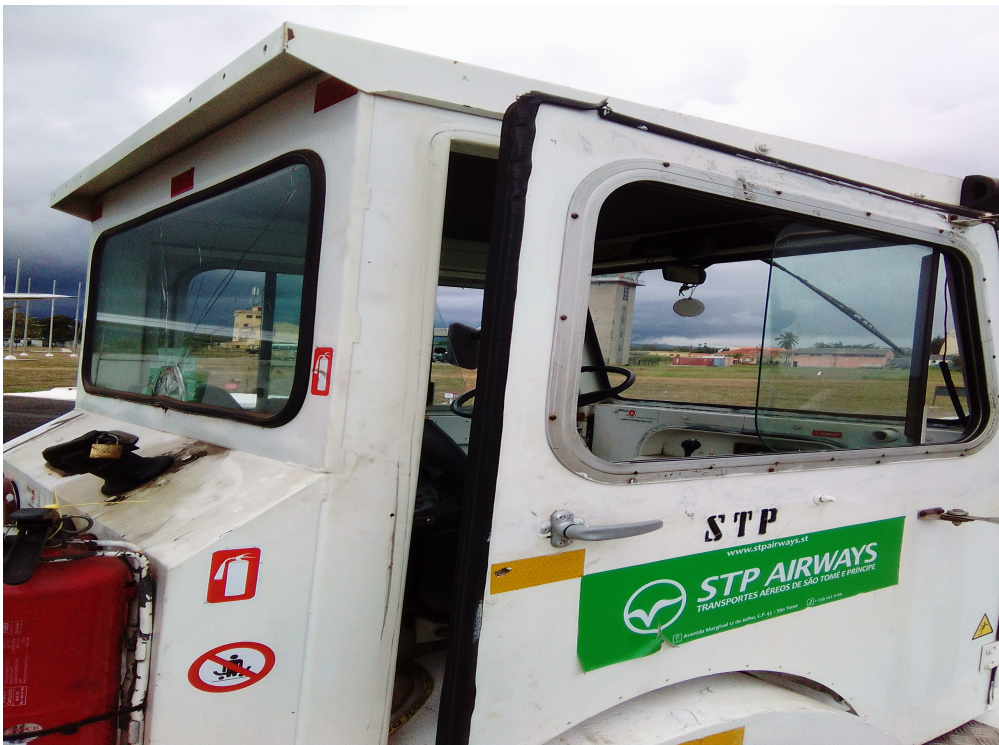
**1.4 OTHER DAMAGE:** Tractor right door partially damaged.

Figure 4: Picture showing rearview and right door of the tractor.

More so the tractor was not technically in perfect condition as we found that the gear was not functioning properly due to missing of one screw and another one was loosened that caused it to release from original parking position to the rear position.

The right hand side door of moving tractor was left open what made it to hit the aircraft fuselage.
