## **AIRCRAFT ACCIDENT REPORT**

REPORT ON THE ACCIDENT INVOLVING  
AFRICA' CONNECTION D 228 AIRCRAFT  
REGISTRATION S9-AUN, WHICH OCCURRED  
AT SÃO TOMÉ INTERNATIONAL AIRPORT  
ON 18<sup>th</sup> DECEMBER, 2018

# **NATIONAL ACCIDENT INVESTIGATION COMMISSION**

**AIRCRAFT ACCIDENT REPORT Nº:** AC/18/12/2018/RF

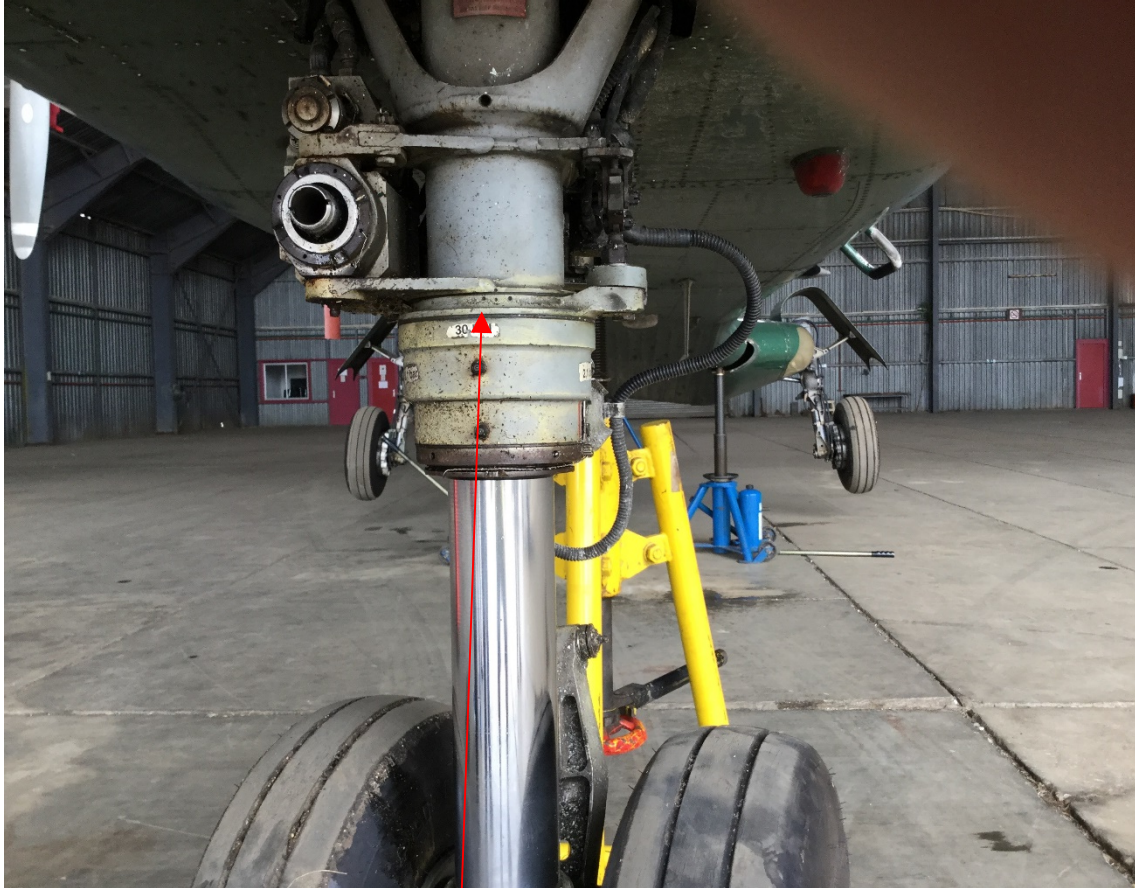
Fig. 1 NACCELE NLG

When towing the airplane, an incorrectly inserted safety pin on the nose landing gear could move out, and cause the lock to engage.

The nose landing gear could be damaged.

Dornier highly recommend the modification of the safety pin P/N UO1A090000 according to fig. 1.

Dornier highly recommends the modification of the safety pin P/N UO1A90000 accordingly.

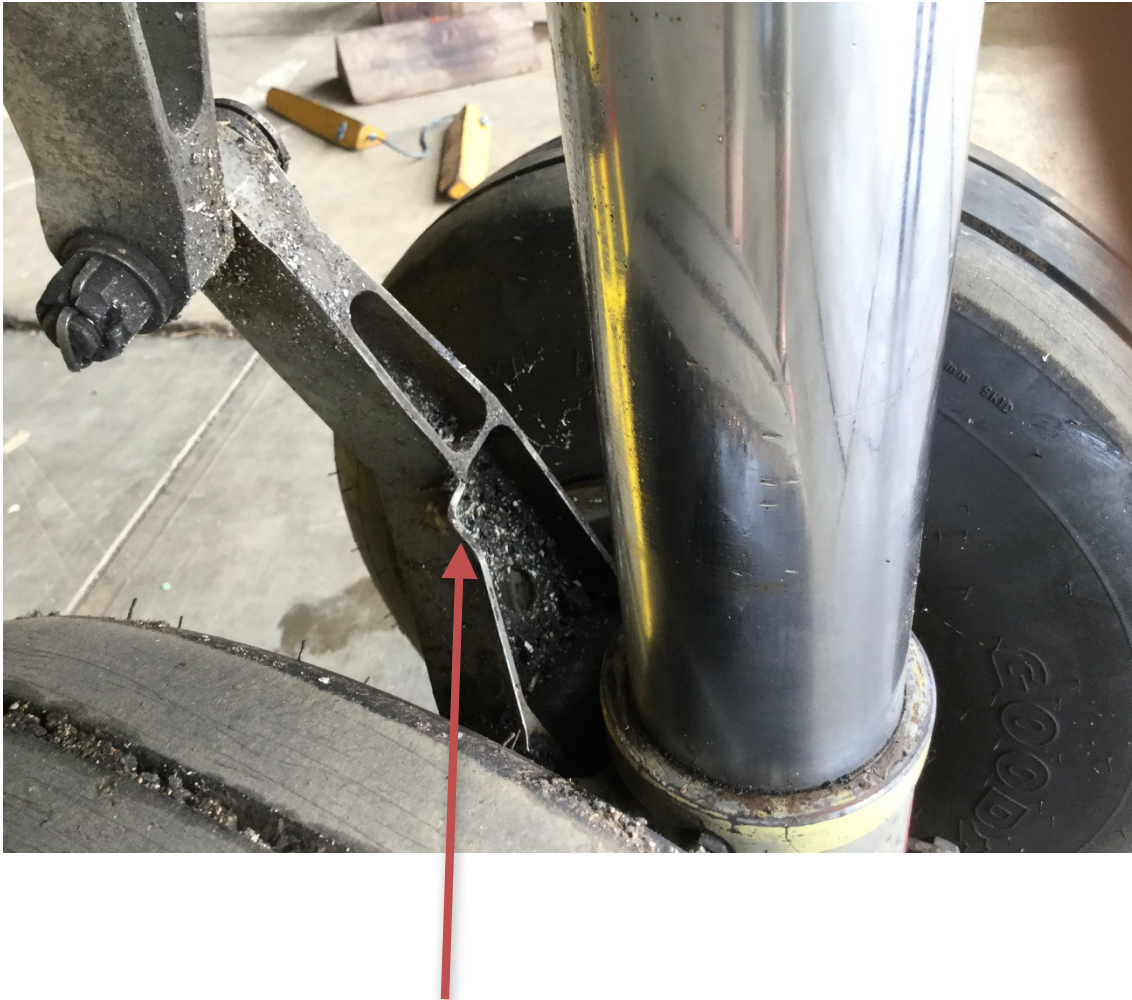
Fig.3 DEFLECTION THE TORQUE LINK ASSY

On the day of occurrence when the pin came out and during turning it affected the nose landing gear torque link that suffered serious damages. No action whatsoever was taken to correct the situation.

During towing of the aircraft, the pin for towing came out and at time of turning it damaged the nose landing gear torque link affecting the alignment and centering of the nose wheel.

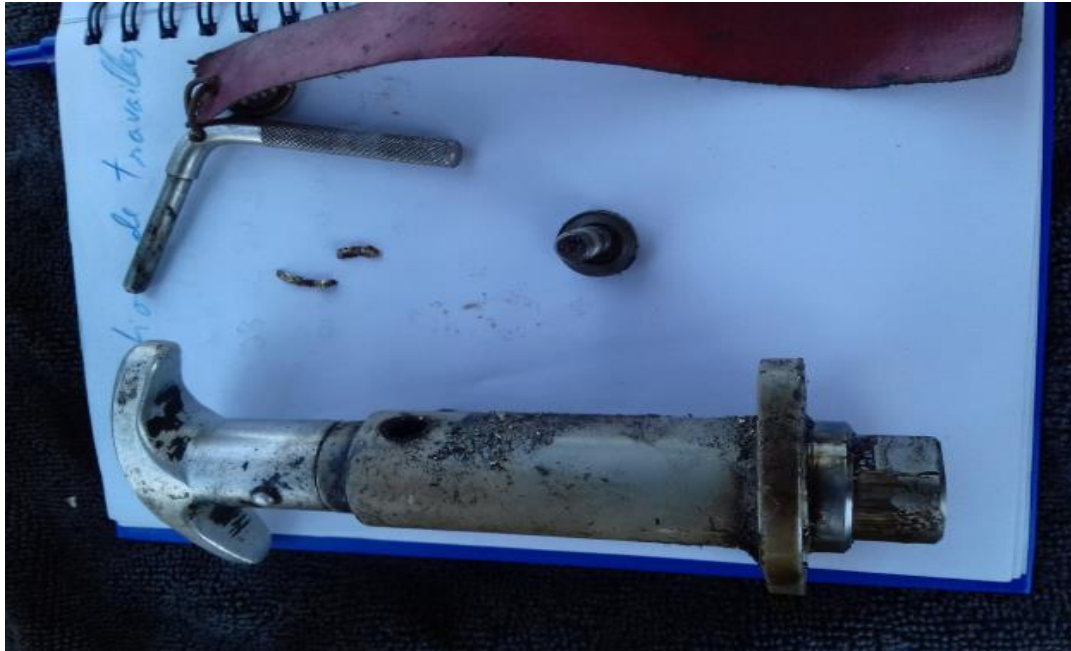
Fig.4 Safety Pin (for towing) and NLG Steering Coupling Mechanism

It is pertinent to emphasize that the manufacturer issued a service bulletin on 28 April 1989 to improve safety pin on Nose Landing Gear (for towing). If the modification according to that service bulletin was effectively complied it could avoid the pin to come out even with strong vibration due to taxiway roughness.

- (14) The crew only reported nose gear technical problem during final approach and emergency landing was declared after go around procedure.
- (15) Modification as recommended in the Service Bulletin nº SI-228-036 was not complied.

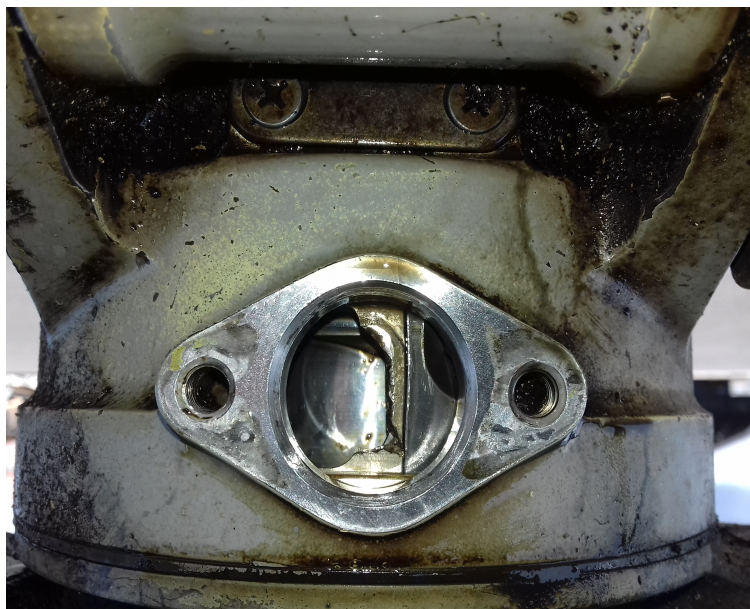
- Deformation of the radome and compartment bag
- Damage of the nose landing gear bay
- Lower skin aft wheel bay shaved
- Skin top fuselage wing damaged
- Longerons damaged inside Top and Lower windows

Fig.5 Part of the nose landing gear damaged

Nose wheel could not be extended because it was stuck in the nose compartment.
