## **AIRCRAFT ACCIDENT REPORT**

FINAL REPORT ON THE ACCIDENT INVOLVING  
AFRIJET ATR 72-212A AIRCRAFT, REGISTRATION TR-ABS  
WHICH OCCURRED AT SÃO TOMÉ INTERNATIONAL AIRPORT  
ON 21<sup>th</sup> MARCH, 2019.

# **NATIONAL ACCIDENT INVESTIGATION COMMISSION**

**AIRCRAFT ACCIDENT REPORT Nº:** AJ/21/03/2019/RF

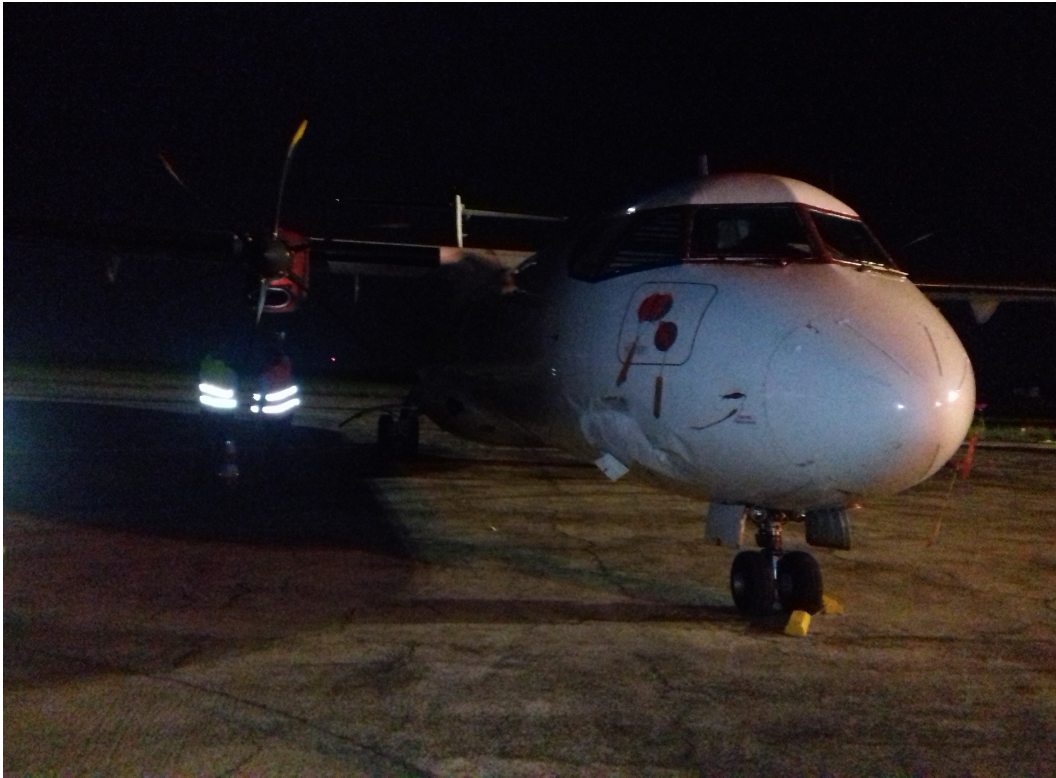
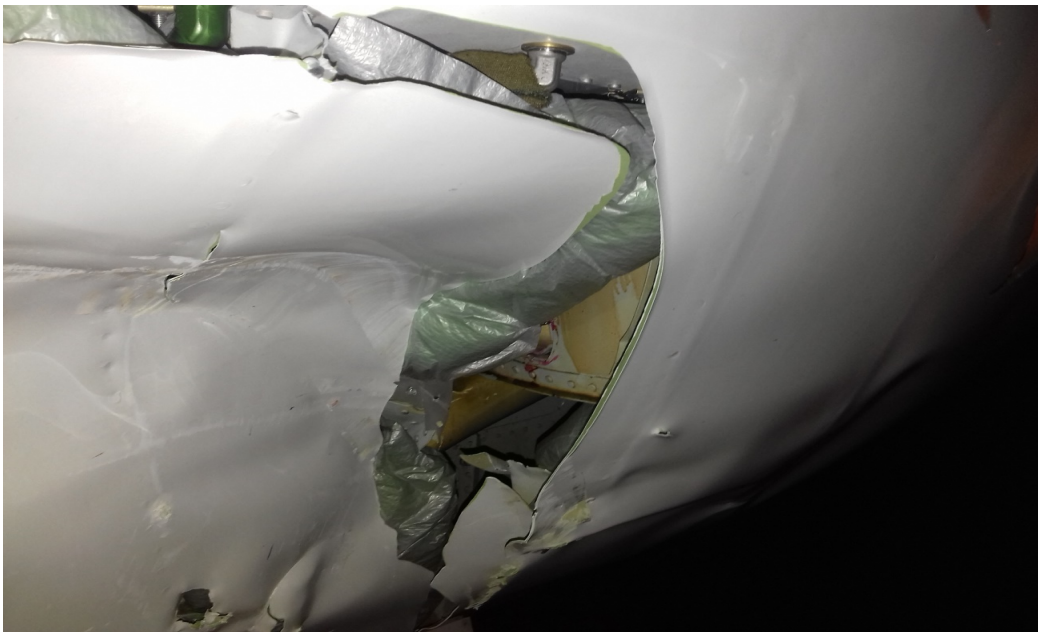
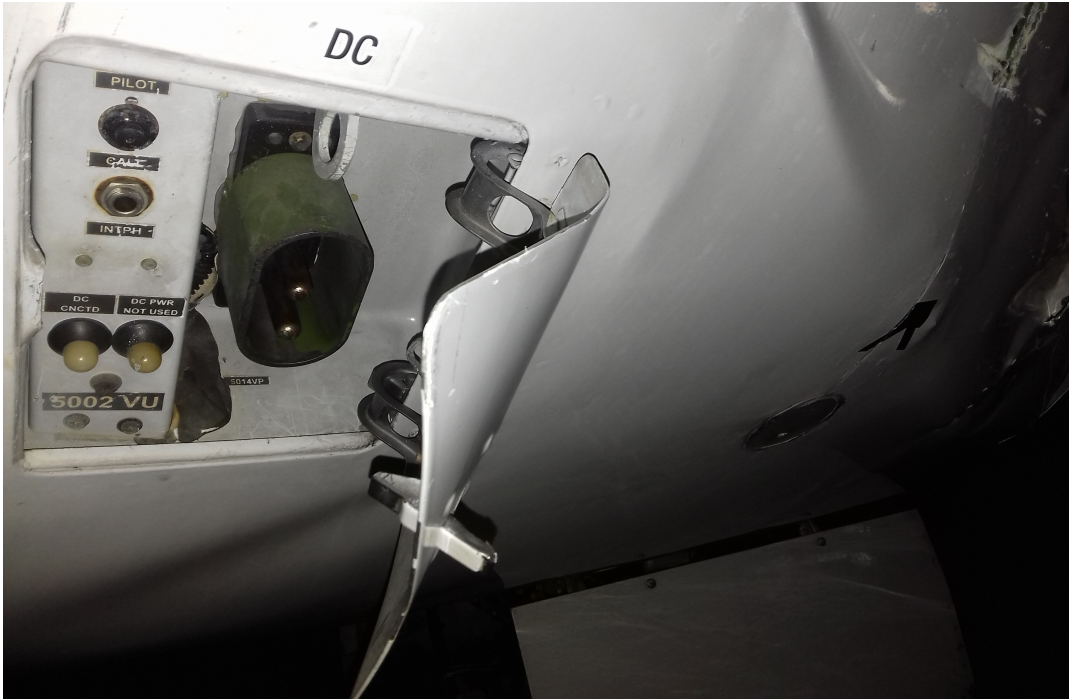
### **1.3 DAMAGE TO AIRCRAFT:**

The aircraft partially damaged.

The impact of the tractor that hit the right front side of fuselage caused structural damages.

With the aircraft parked and ground power connected, the next step should be offloading the passengers as a normal routine but at the precise moment the tractor used to tow the ground power hit the right side of the aircraft frontal part of fuselage near the socket causing serious rupture.

In fact it was the ramp assistant that after removing the tractor from GPU and when driving it out, hit the auto-mechanic that was standing in front of the aircraft, lost control and ultimately hit the aircraft causing damage and serious rupture to the right side frontal part of the fuselage.

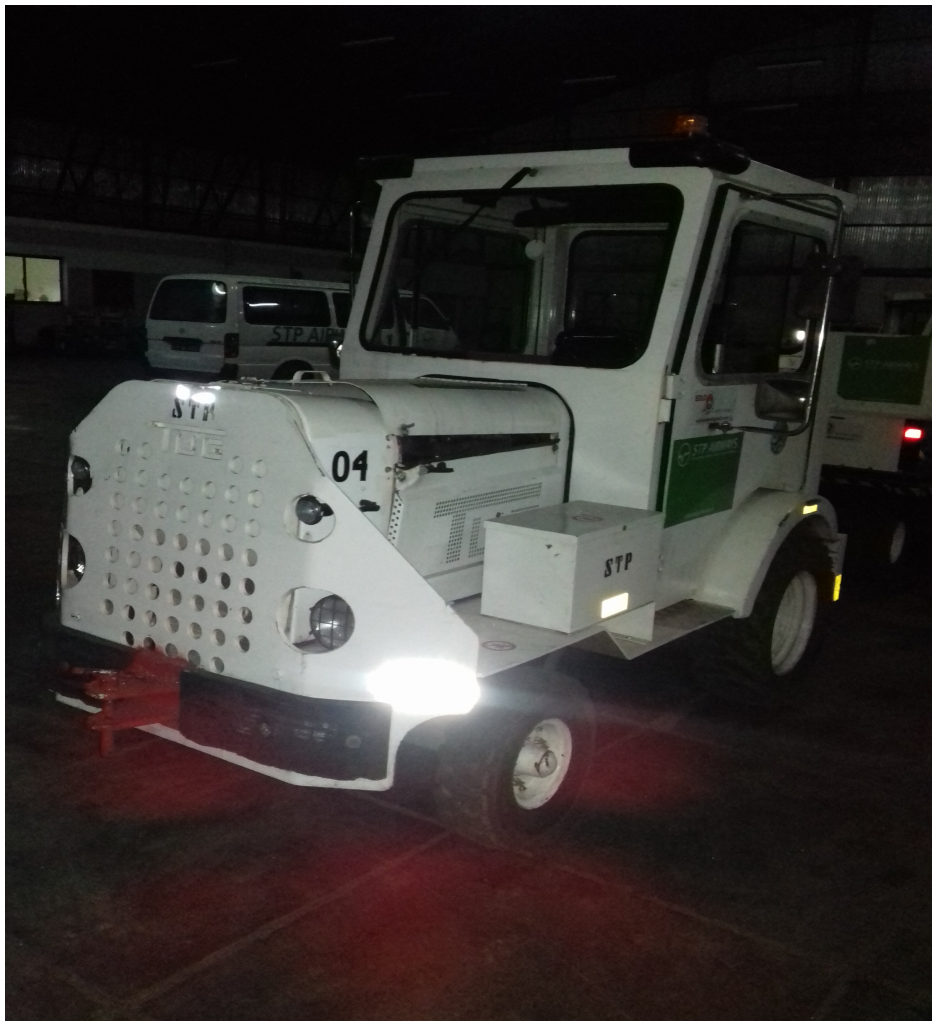
#### 1.4 OTHER DAMAGE:

Tractor partially damaged.

No one could establish the reason that made the driver to be in a hurry and speeding up the vehicle during the night operation when he knew that the tractor steering wheel and braking system were not operating in perfect condition.

3.3.1 Steering wheel and braking system faulty.

3.3.2 Improper maintenance which led to faulty tractor steering wheel and braking system.

STP Airways as handling operator should improve the maintenance work in order to maintain the ground equipment in perfect condition.
