## **AIRCRAFT SERIOUS INCIDENT REPORT**

FINAL REPORT ON THE SERIOUS INCIDENT INVOLVING  
BAE JETSTREAM 32 AIRCRAFT, REGISTRATION CS-DVQ  
WHICH OCCURRED AT PRINCIPE AIRPORT  
ON 19TH JUNE 2024.

# **NATIONAL ACCIDENT INVESTIGATION COMMISSION**

**AIRCRAFT SERIOUS INCIDENT REPORT Nº:** SA/19/06/2024/RF

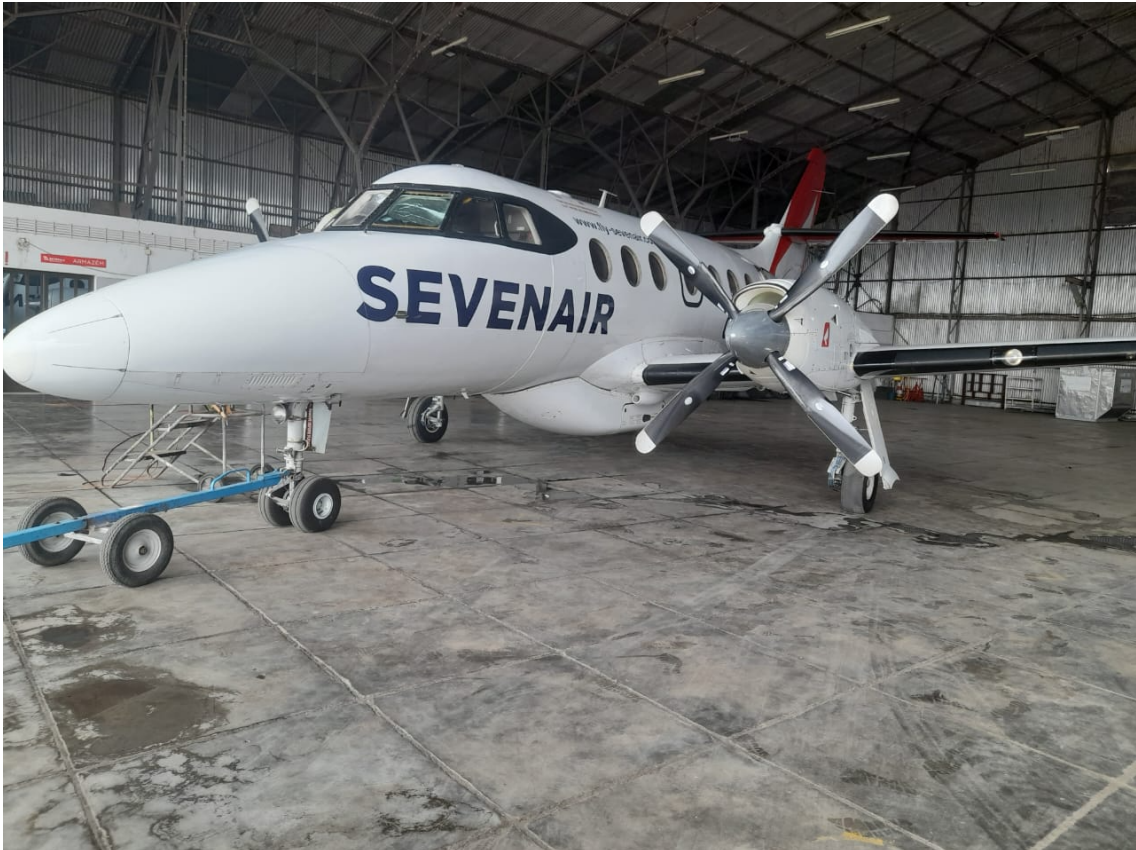
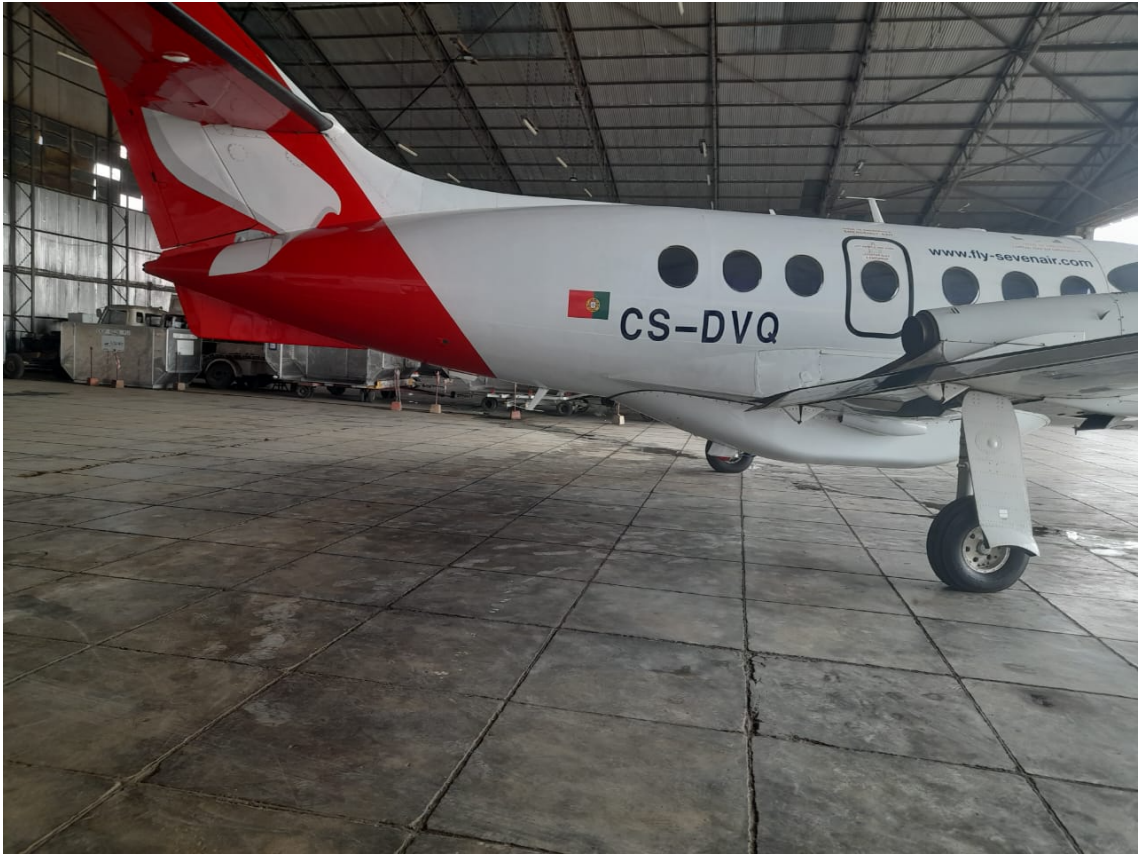
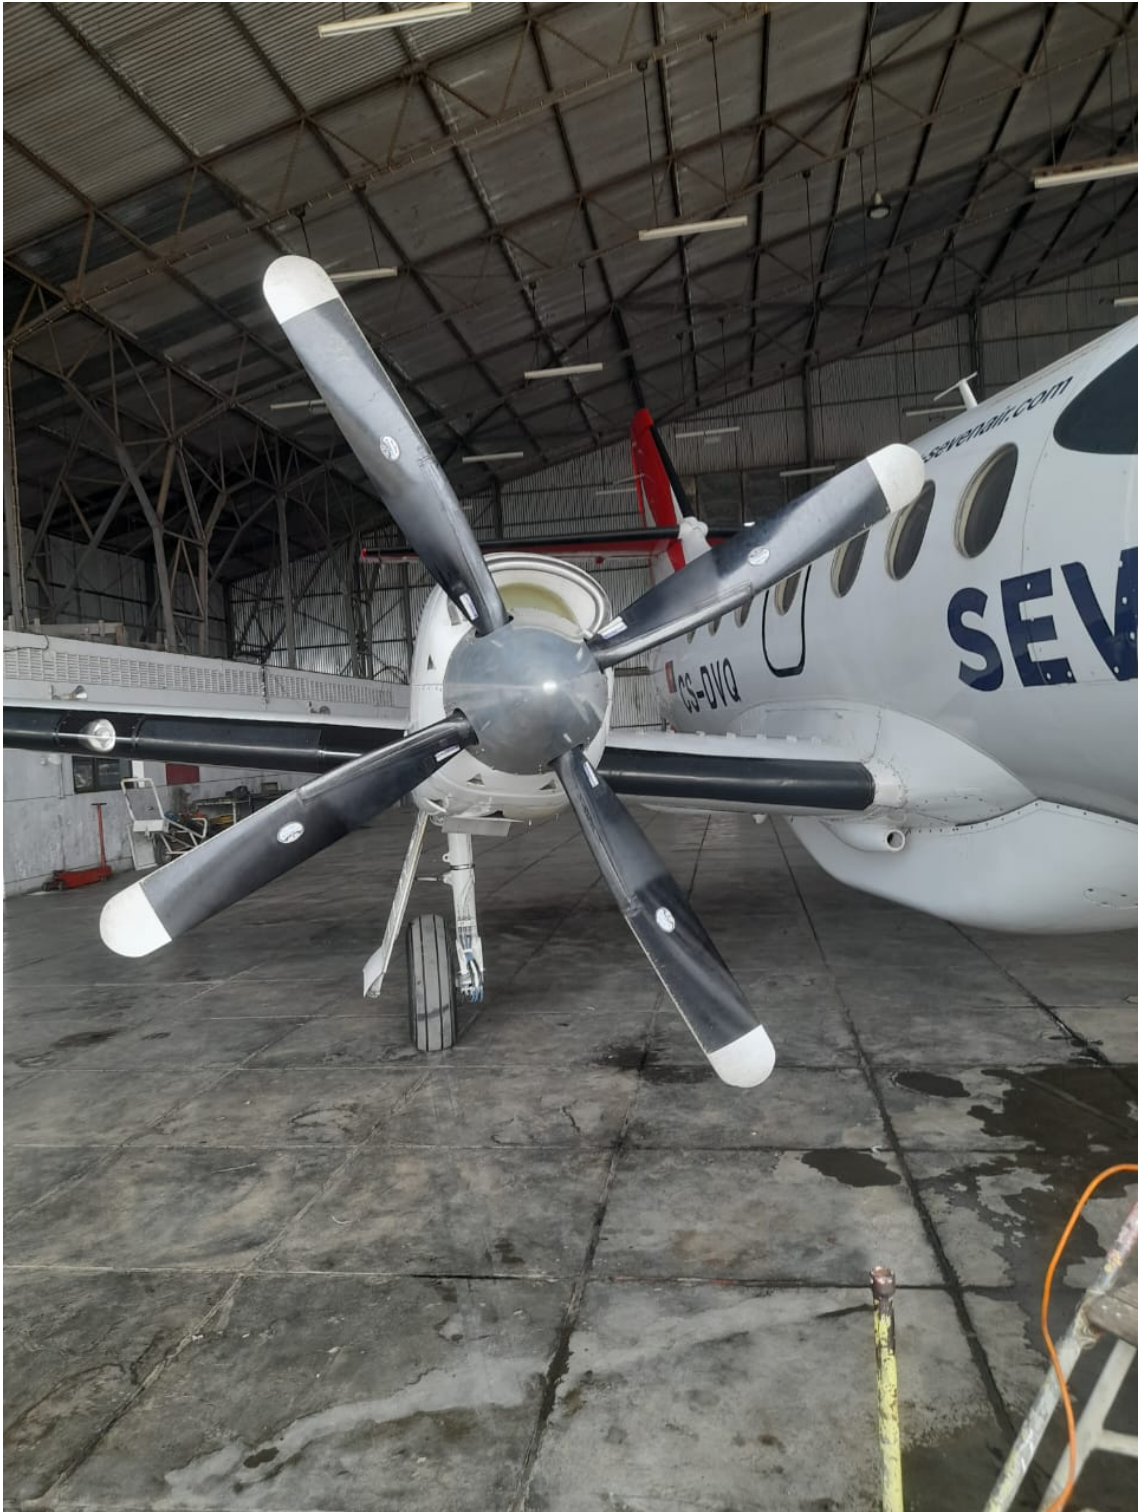
The heavy use of brakes during landing caused them to overheat, which triggered the tire fuse plugs which led to right tire burst.

## 1.3 DAMAGE TO AIRCRAFT: Minor (right landing gear' tire blowout)
