## **AIRCRAFT ACCIDENT REPORT**

REPORT ON THE ACCIDENT INVOLVING  
AFRICA' CONNECTION D 228 AIRCRAFT  
REGISTRATION S9-AUN, WHICH OCCURRED  
AT SÃO TOMÉ INTERNATIONAL AIRPORT  
ON 18<sup>th</sup> DECEMBER, 2018

# **NATIONAL ACCIDENT INVESTIGATION COMMISSION**

**AIRCRAFT ACCIDENT REPORT Nº:** AC/18/12/2018/RF

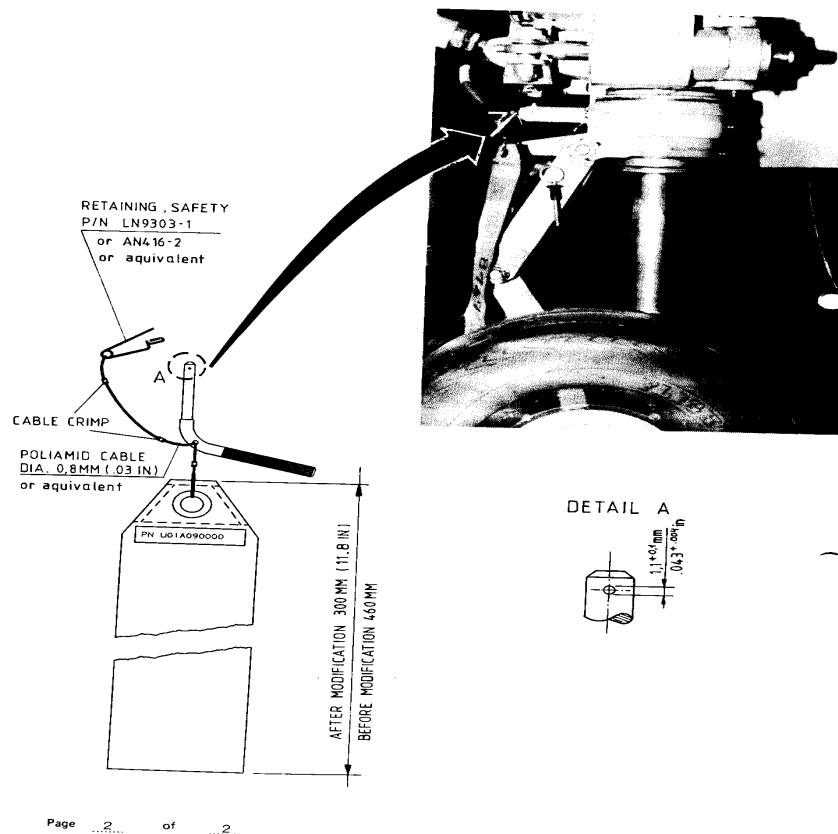
Fig. 1 NACCELE NLG

When towing the airplane, an incorrectly inserted safety pin on the nose landing gear could move out, and cause the lock to engage.  
The nose landing gear could be damaged.

Dornier highly recommend the modification of the safety pin P/N UO1A090000 according to fig. 1.
